Review of Engine Room Fires and Guide to Fire Prevention

by Masaru Iwamoto*, Taira Narisawa* and Akihiko Uotani*

1. Introduction

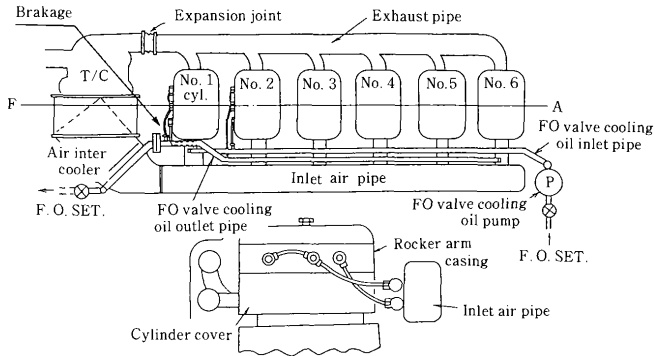
Fig. 17

- (10) Fires at the fuel oil piping of main engines and generator engines are caused by the fuel oil spray due to loose or broken fittings on fuel oil pipings caused by vibration.
The main cause of fire on fuel oil piping of generator engines is fuel oil spraying due to broken fittings on the fuel valve cooling oil piping. (Fig. 17)

FO sprayed out from the No. 1 cyl. FO valve cooling oil outlet branch pipe of the No. 2 G/E because the pipe at the brazing fitting was broken due to vibration and resulted in fire.

- (2) In one case, fuel oil that leaked from the fuel valve cooling oil pipeline splashed and caused an engine room fire. For safety reasons, fresh water cooling should be employed for fuel valve cooling instead of oil cooling. (Fig. 17)

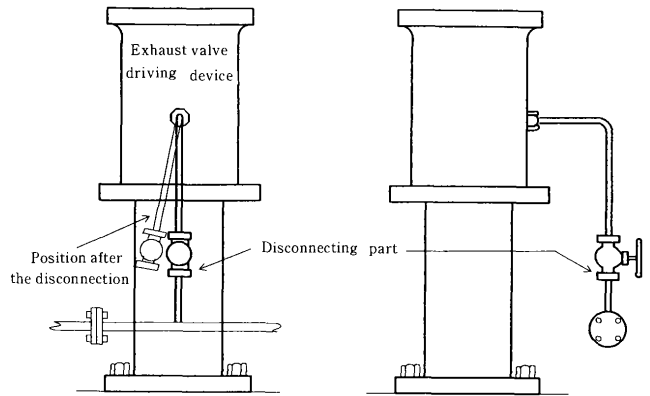
Fig. 18

LO Sprayed out from the LO supply pipe for the No. 1 cyl. exhaust valve driving gear of the M/E, because the pipe at the threaded fitting for the stop valve became loose and was disconnected due to vibration, resulting in fire.

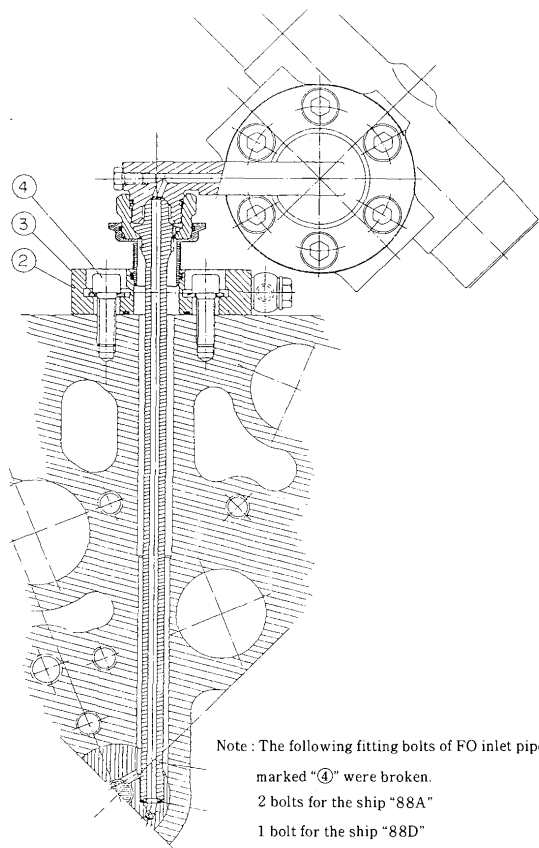
Fig. 20

Note : The following fitting bolts of FO inlet pipe flange marked "④" were broken.
 2 bolts for the ship "88A"
 1 bolt for the ship "88D"

The fitting between the FO supply inlet pipe flange and the FO injection pump.

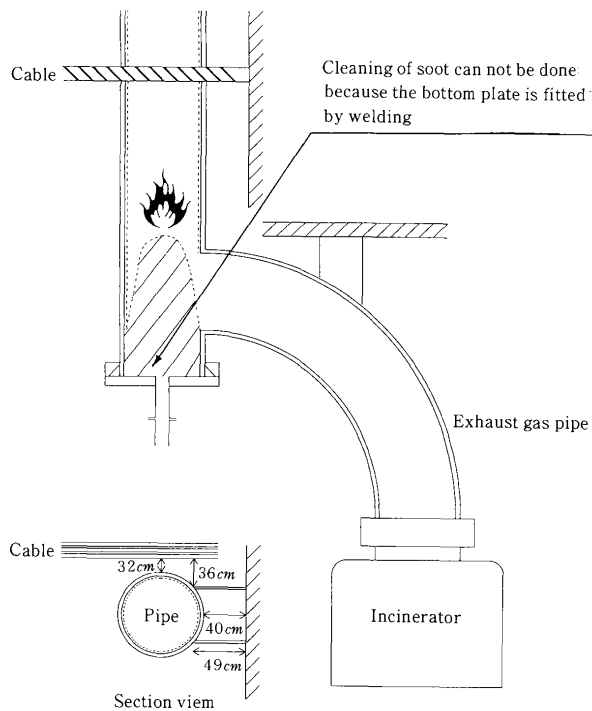
Fig. 21

Fire broke out at the electric cables (38 pcs), which were overheated by a soot fire in the exhaust gas pipe of the incinerator located near the cables.

- (7) Some cases suggest that fires or personal injuries were caused by soot fires in waste oil incinerating equipment. It is advisable that cleaning holes be drilled in the uptake where soot and sludge are liable to accumulate, and cleaning be carried out regularly. (Fig. 21)

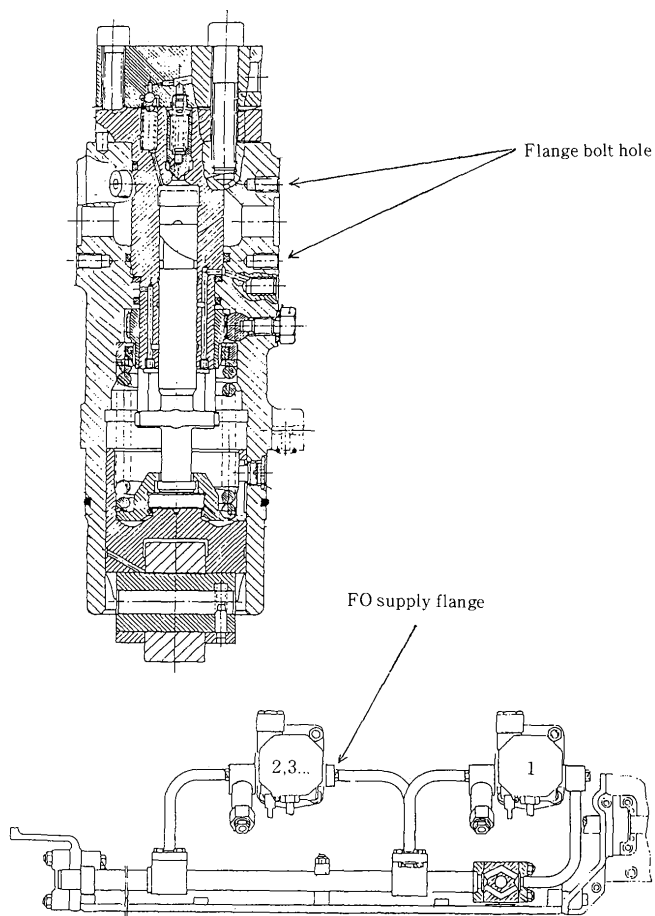
Fig. 23

FO sprayed out from the flange between the No. 4 cyl. FO supply pipe and the FO injection pump because 2 fitting bolts became loose and disconnected. Leaked FO touched a 400°C hot point on the exhaust gas manifold, resulting in fire.

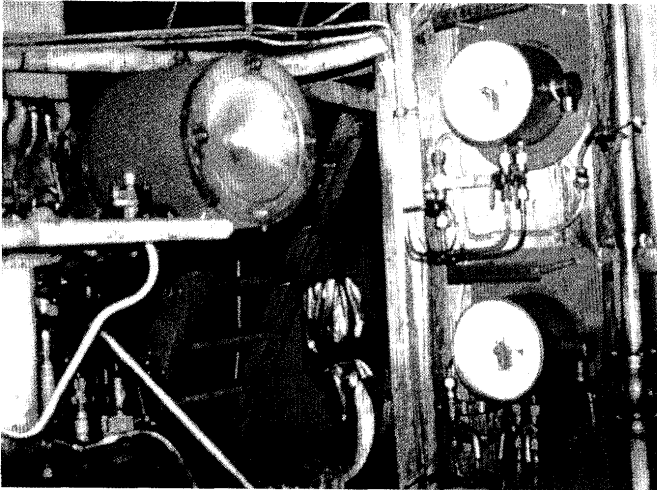
Photo 1

FO sprayed out from the FO strainer differential pressure gauge pipe of No. 2 G/E, because the end cover of the inlet air suction manifold hit the pipe due to an explosion in the manifold resulting from an abnormal condition of the air inlet valve of No. 2 G/E, resulting in fire.

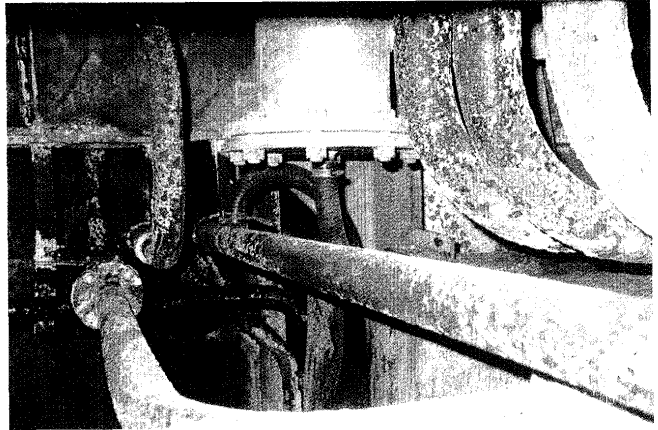
Photo 4

FO leaked onto the M/E exhaust gas pipe and fire broke out because the vinyl hose, which was temporarily fitted to the bottom cover of the FO mixing column was disconnected.

- (4) For flammable oil pipelines, non-metal pipes, not approved by the Society should not be used. (Photo 4, Figs. 22 and 25)
- (5) In one case, a fire involving personal injuries and fatalities occurred due to lubricating oil leaking and splashing from a manual duplex lubricating oil strainer during the change over operation of bilter elements under pressure. Strainers for flammable oils should not be opened for cleaning while the ships is at sea. Instead, as far as practicable, maintenance and reconditioning work should be done in port, ensuring there is no positive pressure. It is also recommended for safety that self-cleaning-type flammable oil strainers with higher internal pressures and less frequent overhauls be used as secondary strainers. (Photos 14, 15 and 19)

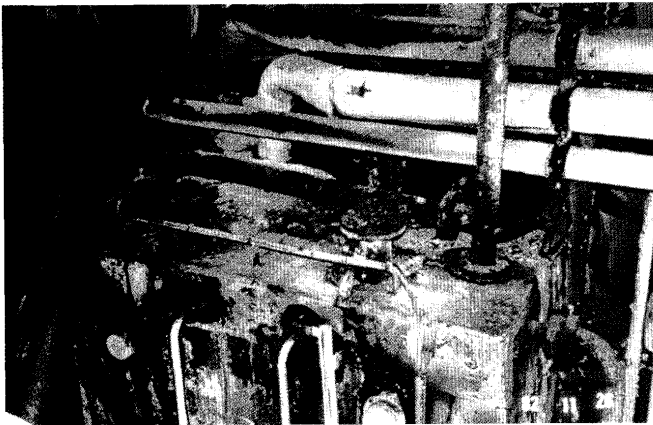
Photo 2

Waste oil sprayed out from the fitting cover of the waste oil tank float gauge, because the cover bolts had not been tightened and the steam cleaning valve opened due to mis-operation, resulting in fire.

- (e) Don't leave engine room doors open. Furthermore, it is nonetheless important for preventing engine room fires to keep engine rooms always oil-free and clean. (Photos 2 and 3)

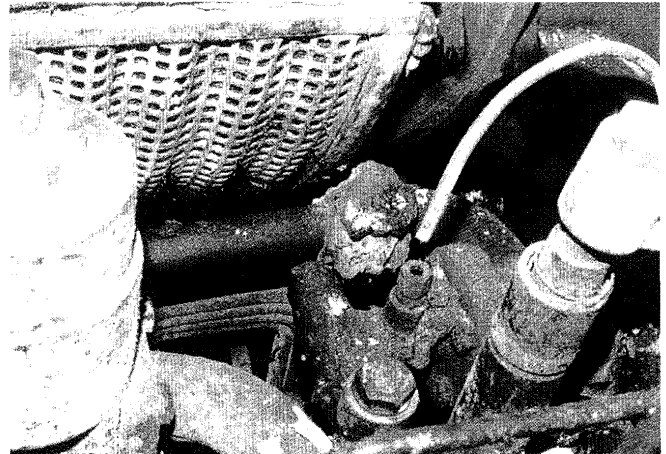
Photo 5

FO leaked onto the T/C and exhaust gas pipe of the No. 1 G/E from the pressure gauge pipe fitted to the FO supply piping because the copper pipe at compression joint was broken due to vibration and resulted in fire.

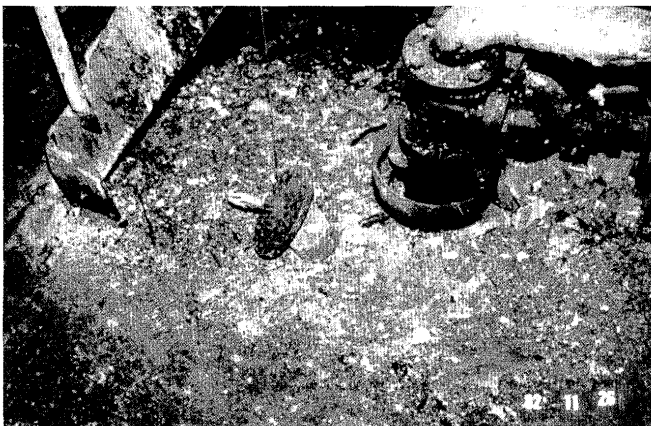
Photo 3

The float gauge cover of the waste oil tank was blown off.

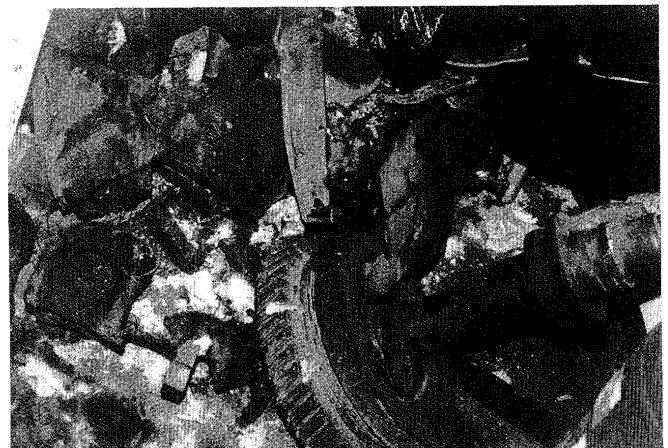
Photo 6

The T/C casing of the M/E was broken and all of the turbine blades were detached by an explosion.

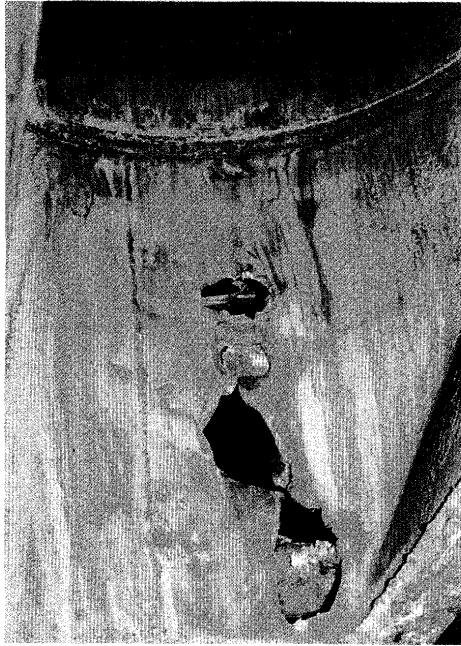
Photo 7

The exhaust gas pipe was holed by the pieces of the T/C casing of the M/E blown off by an explosion.

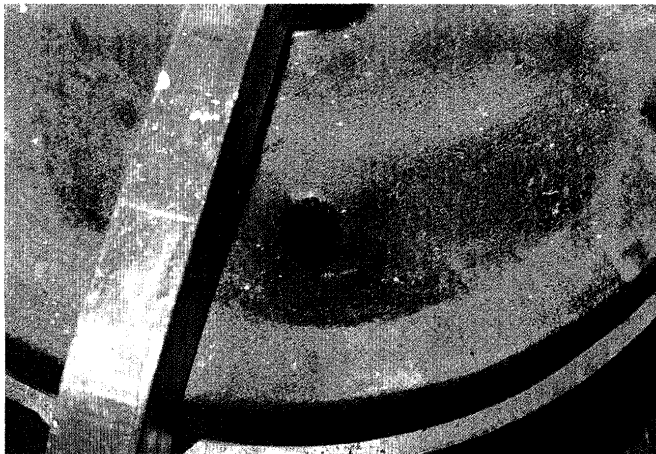
Photo 8

The turbo charger of the M/E exploded and fire broke out because the M/E No. 6 cyl. piston crown was holed and piston cooling LO leaked.

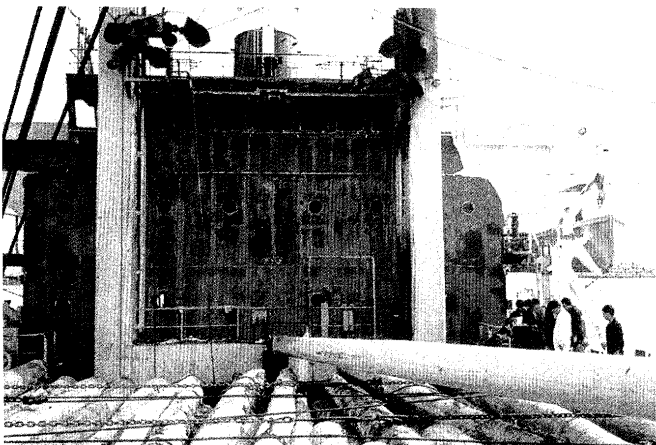
Photo 9

Accommodation on the poop deck was completely burnt out due to an engine room fire when fully laden with timber cargo.

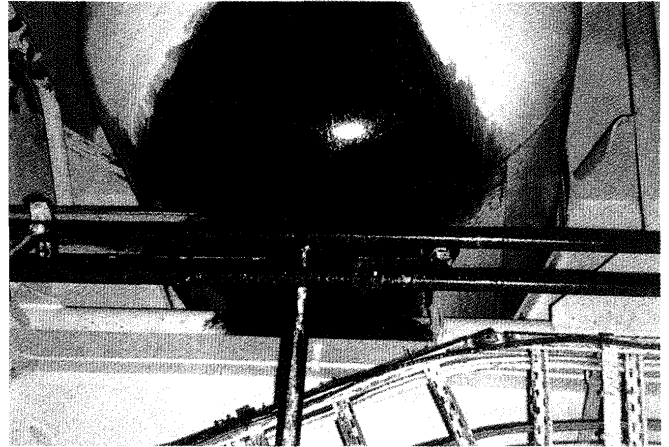
Photo 10

FO sprayed out from the FO supply pipe flange of the No. 2 G/E, because the fitting bolts were disconnected, resulted in fire.

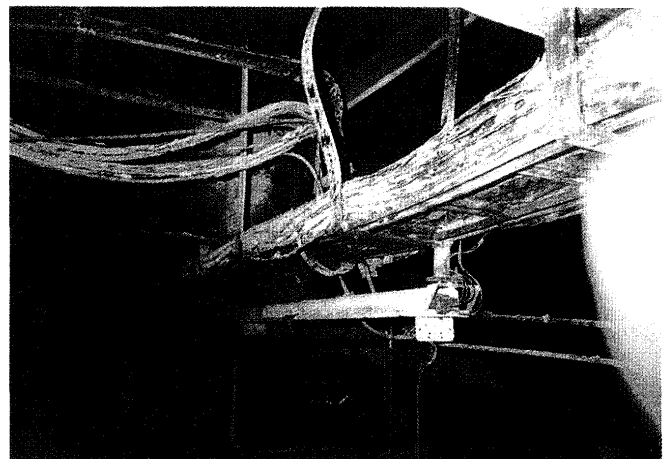
Photo 12

Electrical cables were burnt by a FO spray fire in the No. 2 G/E.

- (6) Among ships that had engine room fires, 75% occurred when ships were underway, and 52% lost self-propelling power. The prime causes of loss of propelling power after the fire was brought under control include burnt propelling machinery and loss of functions of electric cables soaked in sea water. Nonetheless, important causes can be found in the burnt electric cables laid on the upper ceiling of the generator flat with consequent loss of the main electric power supply. Laying electric cables on or underneath the generator flat, or distributing generator engines to both sides of a ship can be an effective alternative arrangement to ensure continued navigation even after a fire aboard the ship. Furthermore, if the possibilities of burn damage to cables in a bundle are reduced, the likelihood of crew members being suffocated due to a large bulk of toxic gasses produced by the burning cable insulations can be reduced. (Photos 12 and 13)

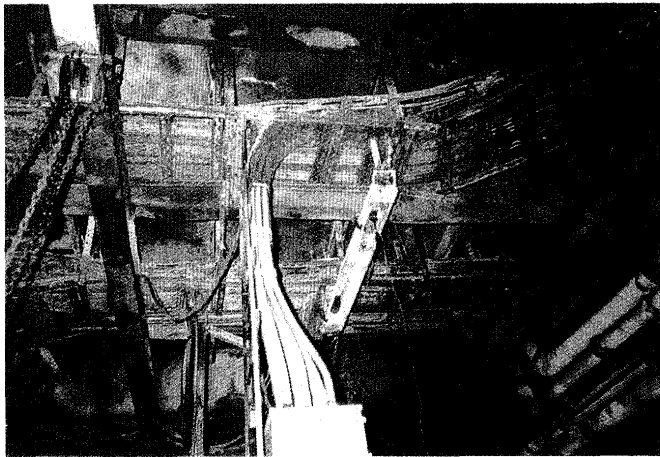
Photo 13

Some of electric cables arranged under the ceiling were burnt, but none of the cables arranged vertically from the generator terminal box were burnt.

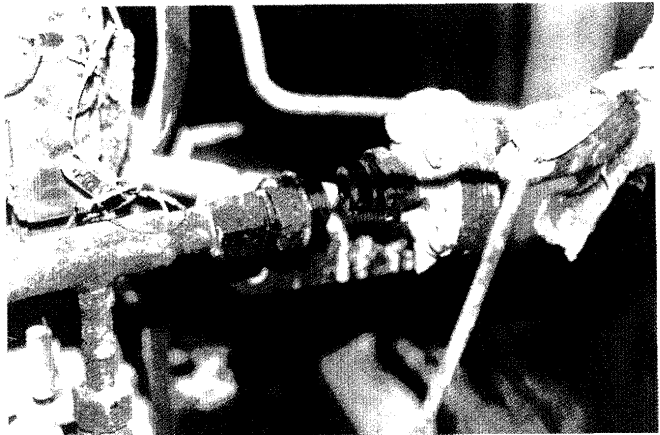
Photo 16

- (12) It is necessary for the pipe connection between the fuel oil piping and the burner of a top firing boiler to have a flexible construction, because the burner of a top firing boiler is located at the upper part of the boiler and is subject to high levels of vibration.

DO sprayed out from the DO supply pipe of the aux. boiler top firing burner because the union fitting in the pipe had become loose and disconnected due to vibration, resulting in fire.

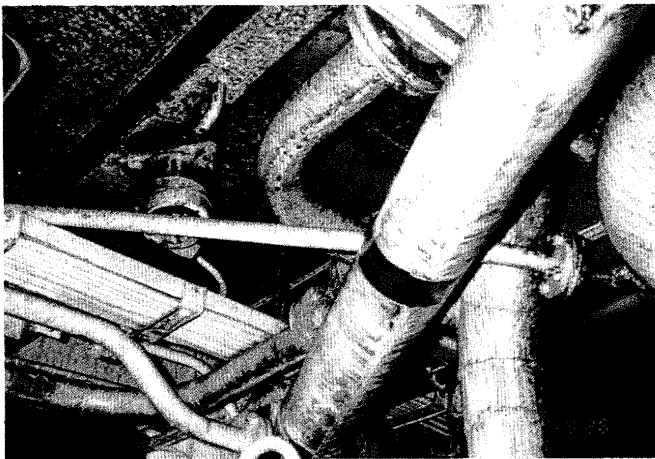
Photo 14

The trace of LO spray

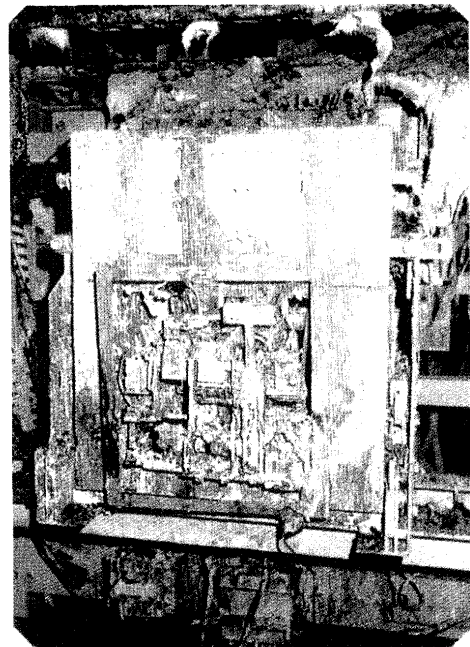
Photo 17

- (8) Most fires in electrical equipment and installations such as switchboards and generators were caused by the overheating contactors or connec-

Fire broke out at the ACB contactor of a T/G due to overheating.

tions of conductors with consequent burn damage. It is considered feasible to reduce electrical fires aboard ships by enforcing regular checks on connected portions of electrical equipment and installations including additional tightening of screws. (Photo 17)

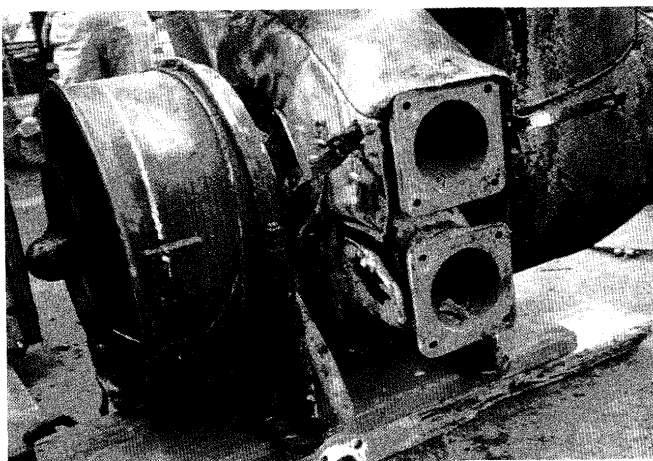
Photo 15

Leaked LO touched a hot-point on the T/C casing.

safely covered. All insulating materials which were stripped off for inspection and maintenance work should be restored the original state as soon as possible. (Photo 15)

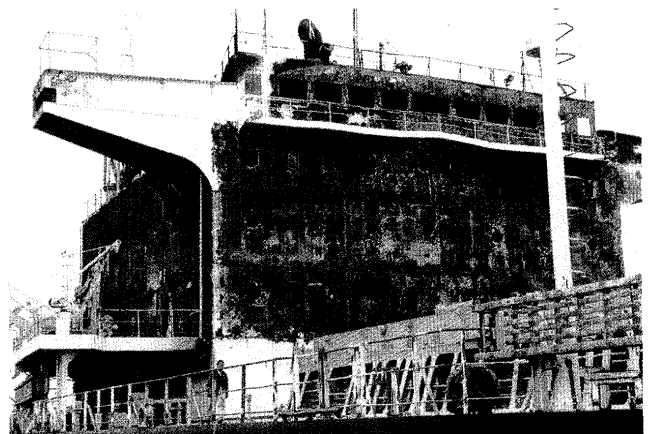
Photo 18

Accomodation completely burnt.

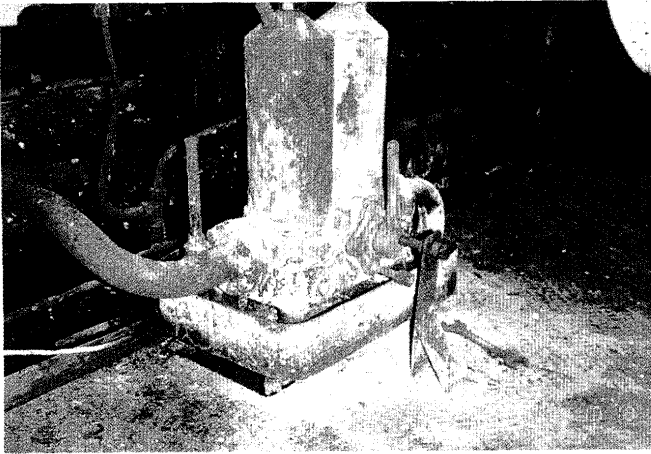
Photo 19

LO sprayed out from the T/C LO strainer, because the fitting bolts of the packing retaining cover of the change over cock were loosened during operation, resulting in fire.

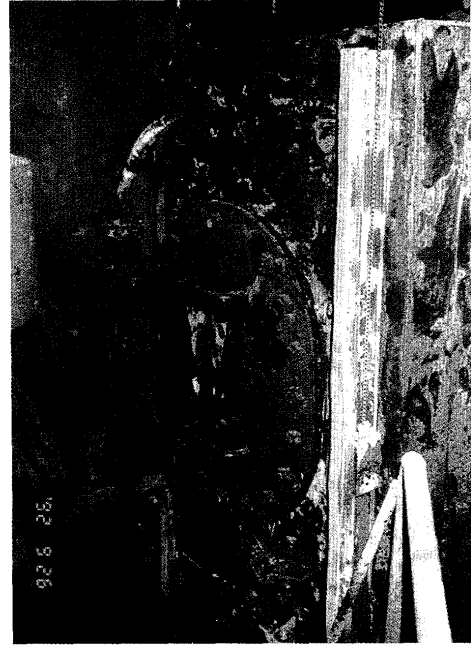
Photo 20

Melted and carbonized rubber packing protruded slightly from around the manhole cover of a waste oil tank .
The sight glass in the overflow pipe melted.
