Review of Engine Room Fires and Guide to Fire Prevention

by Masaru Iwamoto*, Taira Narisawa* and Akihiko Uotani*

1. Introduction

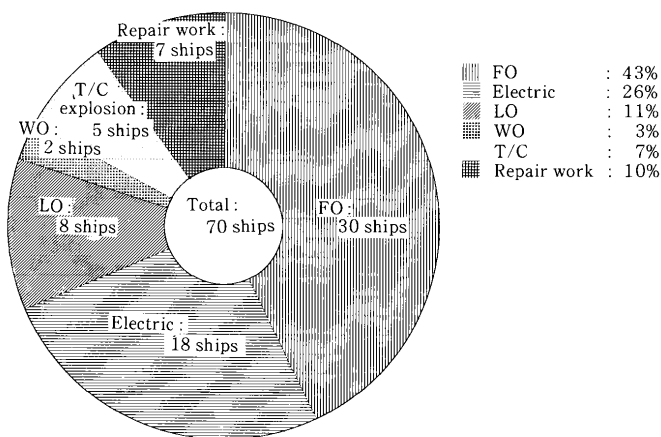
Fig. 4 Causes of fire

- (4) The main cause of fire resulting in an un navigable condition is a main electric source failure caused by the main switchboard or the main electric cables under the ceiling burning due to a spray of fuel oil or lubricating oil igniting. (Fig. 4)

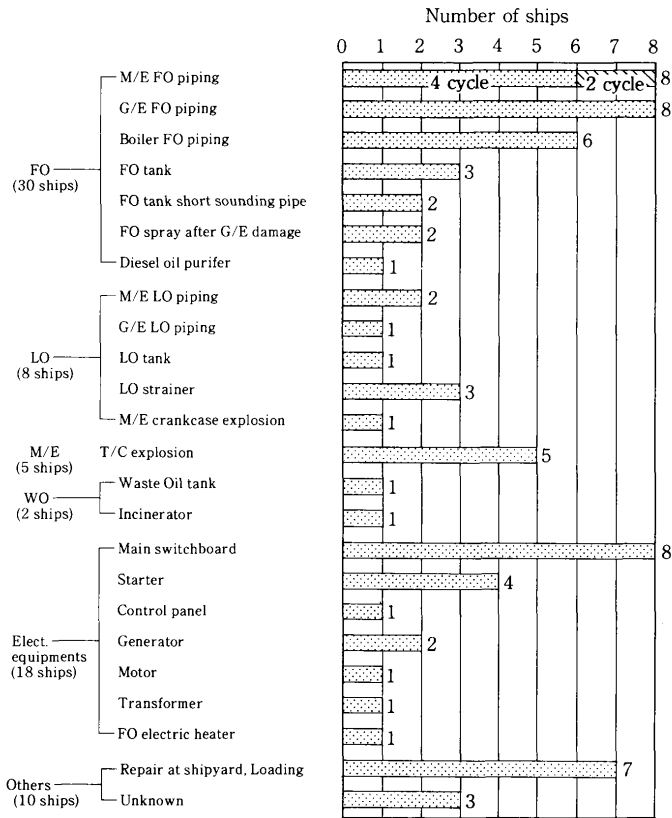
Fig. 7 Sources of ignition

- (9) The fuel oil piping of main engines and generator engines and the main switchboard are the main source of fire followed by fuel oil piping of the boiler. (Fig. 7)

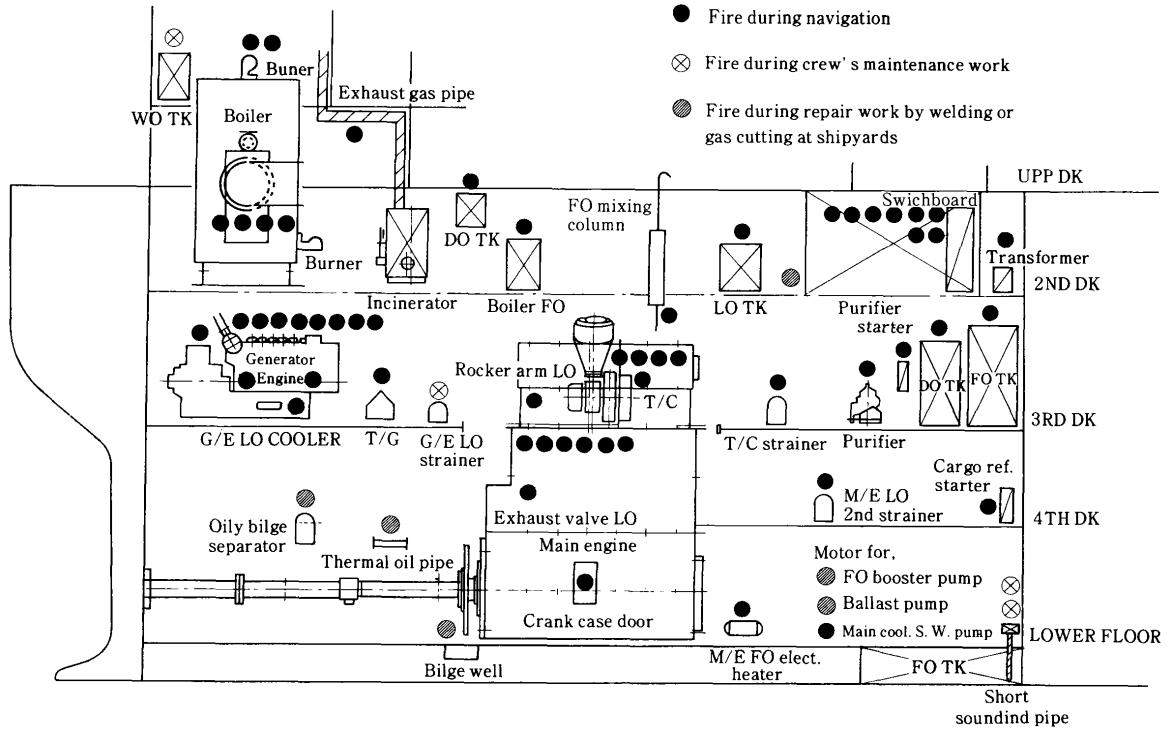
Fig. 16 Sources of fire in engine room

- (10) It was revealed that the locations of engine room fires are not evenly scattering over the machinery space, but are concentrated within specific high-risk areas. Specifically, spaces incorporating oil fuel pipes connected to the main engines and generator engines, oil fuel pipe to oil burners of boilers, exhaust gas pipes, turbochargers and main switchboards are considered to be dangerous spaces. It, therefore, is considered necessary to take concentrated fire prevention measures tailored to high-risk spaces. (Fig. 16)

- (11) It was also revealed that the lower floor of the machinery space has the lowest risk of fire at sea. However, fires due to human errors are liable to occur during welding or gas cutting work when the ship is in port or in a shipyard. In this connection, verification of the present conditions of the space before starting maintenance/repair work is considered to be effective for preventing engine room fires. (Fig. 16)

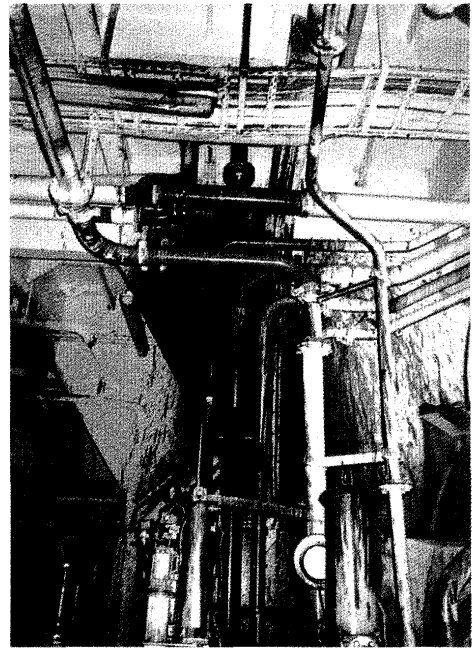
Photo 11

FO sprayed out from the FO supply pipe flange of the No. 2 G/E, because the fitting bolts were disconnected, resulted in fire.
